Stony Creek

Protecting our Water

Assessing the History for a Clean Future

FEASIBILITY STUDY

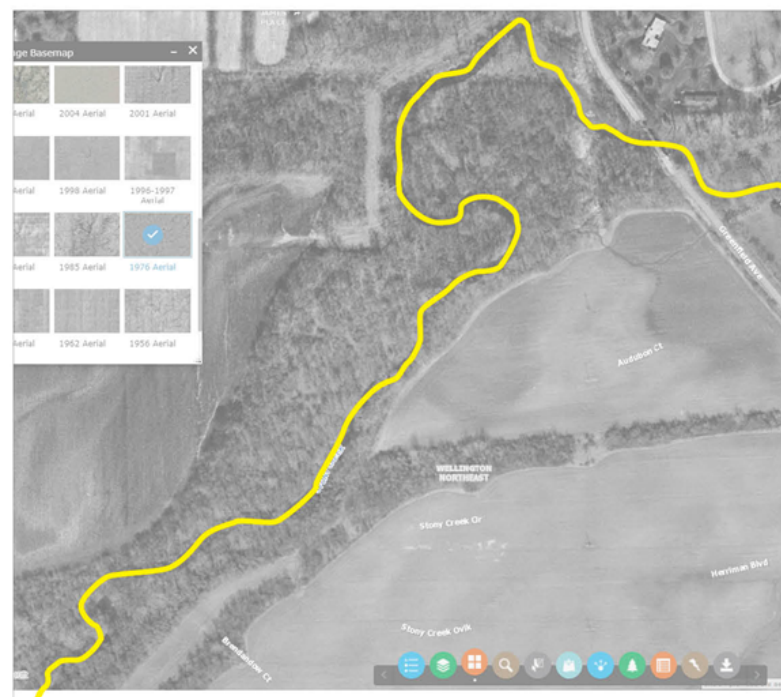
FIGURE 2.6-1 | Stoney Creek. 1976

— HISTORICAL (CURRENT FOR THIS IMAGE, 1976) ALIGNMENT

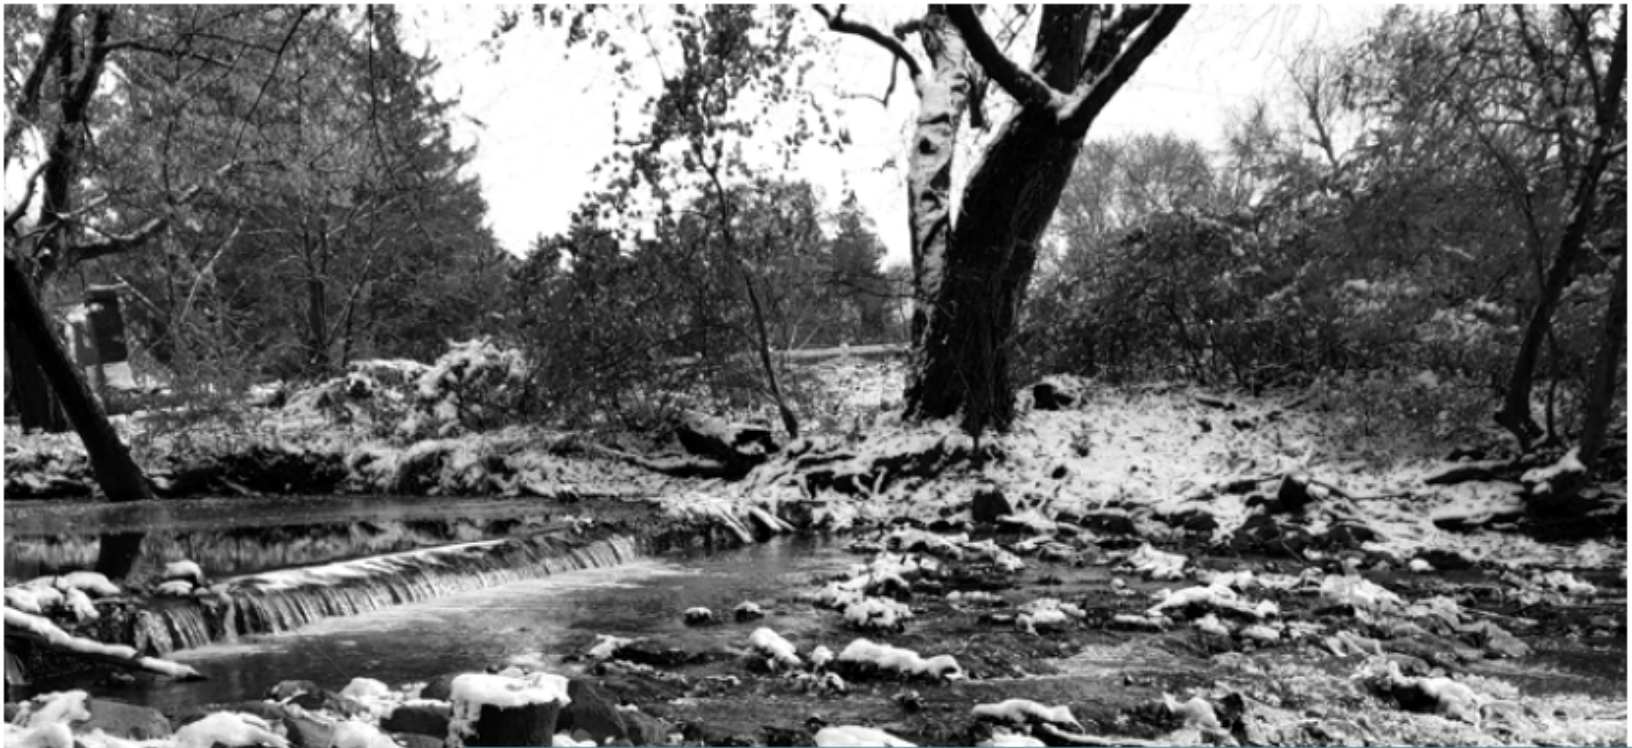
Impact of Low Head Dams on Water Quality

Impounded Water

- Lower water velocity
- Higher water temperature
- Lower dissolved oxygen concentrations
- Excessive algal growth can be present
- Higher nutrient concentrations and riverbed sedimentation
- Degraded fish communities
- Lower Biodiversity

Free-Flowing Waters

- Higher water velocity
- Cooler water temperature
- Adequate dissolved oxygen concentrations
- Higher sediment transport
- Nutrients distributed efficiently
- Larger mussel and macroinvertebrate populations
- Higher Biodiversity
